## **SURVEY OF CHILDREN'S PLAY AREAS**

### **OAKEN GROVE PARK**

## OAKEN GROVE PARK PLAY EQUIPMENT

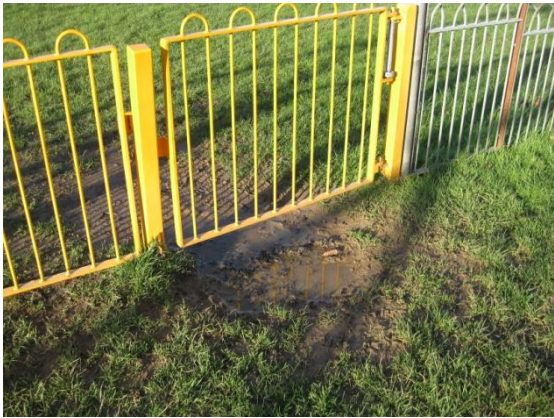
Fig.1(a). Northern side entrance.

At the northern side entrance there are puddles of water and mud (Fig.1a,b)

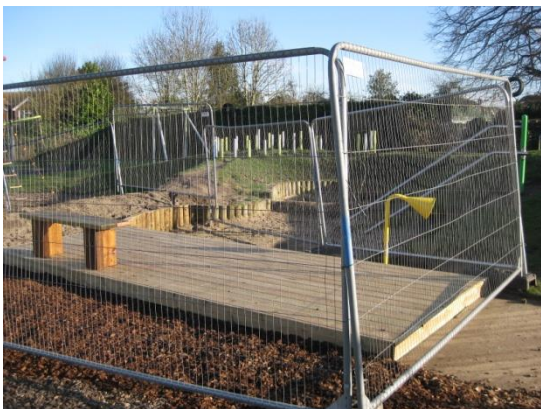
Fig.2. Fenced-off area.

There is a fenced-off, no entry section within the play area. For new equipment or a sandpit? (Fig.2)

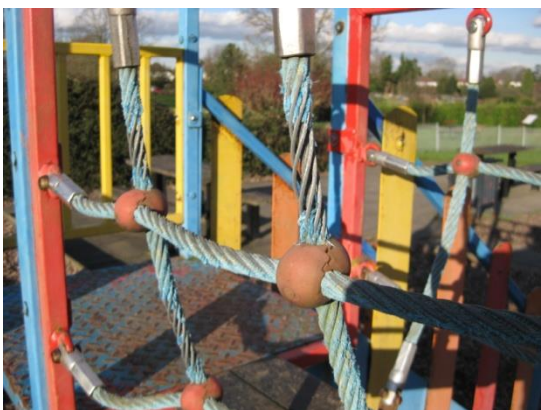
Fig.3(a). Activity frame.

This is rusting and needs repainting (Fig.3a,b)

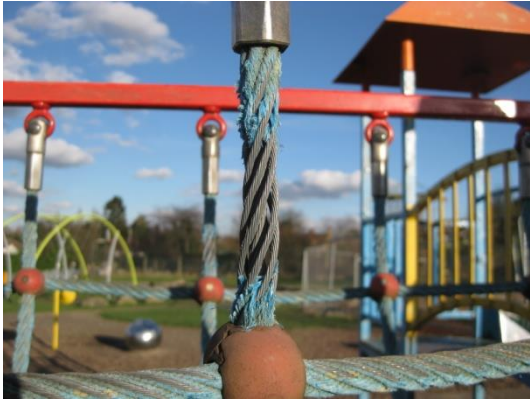
The blue plastic covering to the twisted wire rope rigging is badly worn leaving the metal exposed. It needs replacing (Fig.3c)

Fig.3(c). Worn wire rope.

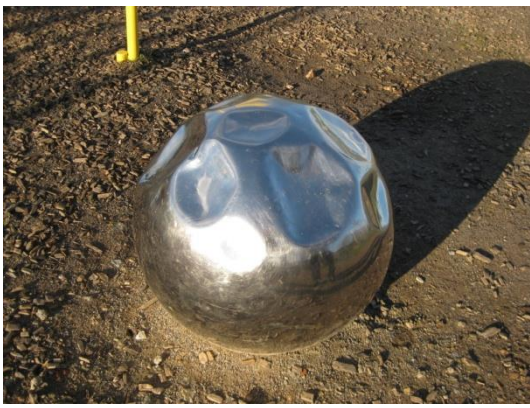
Fig.4(a). Metal ball.

Fixed silver metal ball: this is indented (kicked in?) (Fig.4a,b)

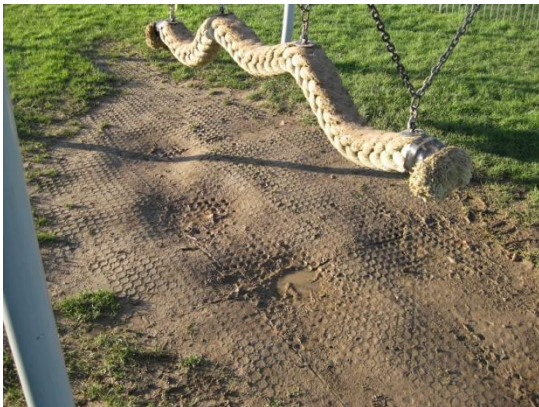
Fig.5(a). Rope swing.

The rope itself is becoming worn and frayed. Underneath the swing, it might be beneficial to put wood shavings on top of the existing rubber matting, as this is hollowed out and muddy in places (Fig.5a,b,c)

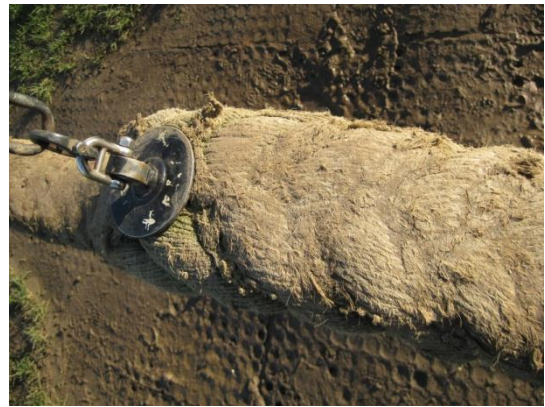
Fig.5(b). Fraying rope.

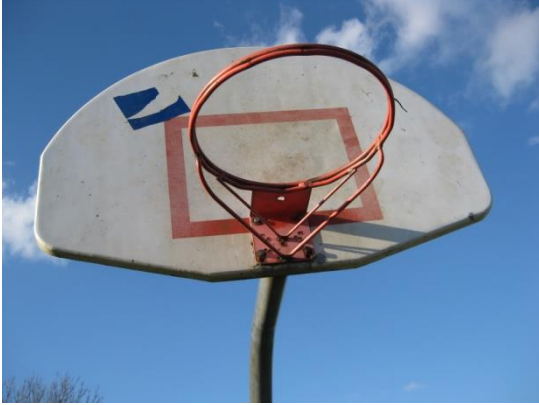
Fig.6. Basket ball frame.

Should this have a net? (Fig.6)

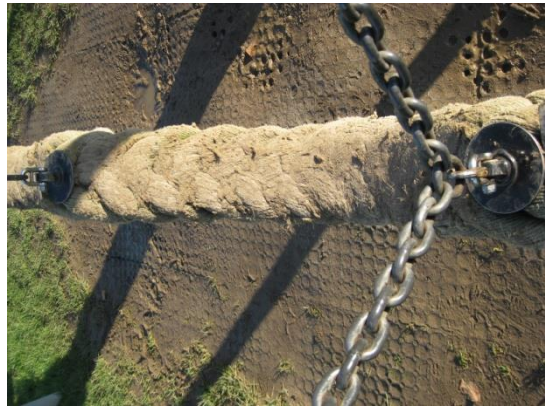
Fig.5(c). Fraying rope.

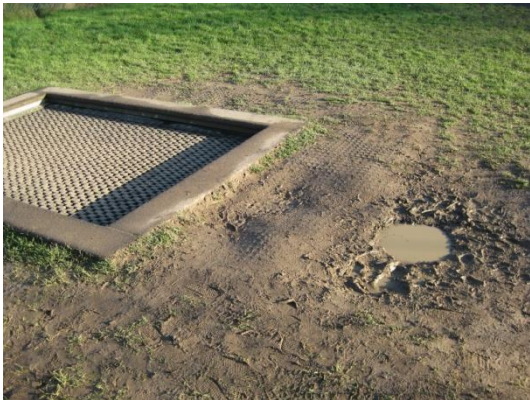
Fig.7(a). Trampoline.

This is a good idea, but is the concrete surround safe? Should it be rubberised?

The area surrounding the trampoline is muddy with puddles of water (Fig.7a,b)

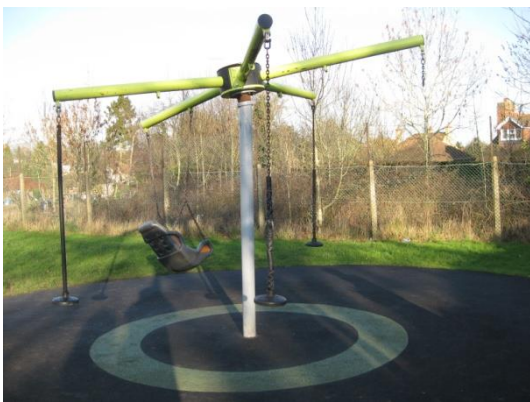
Fig.8(a). Rotating swing.  
seat.

The swinging seat has been set on fire, leaving fire damage and a hole – needs replacing (Fig.8a,b,c)

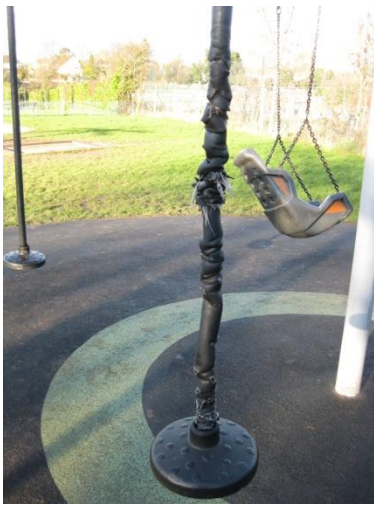
Fig.8(d). Rubber-covered hanging chain.

The rubber covering to 2 hanging chains is fraying and needs replacing (Fig.8d,e)

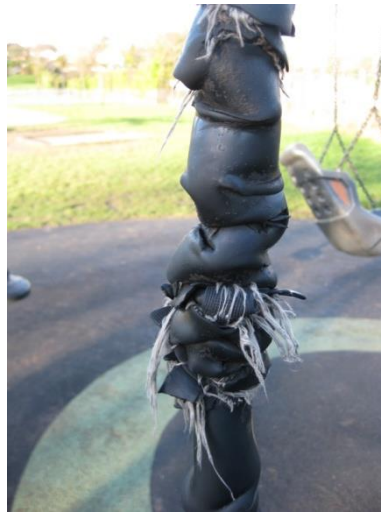
Fig.8(e). Frayed cover to chain.

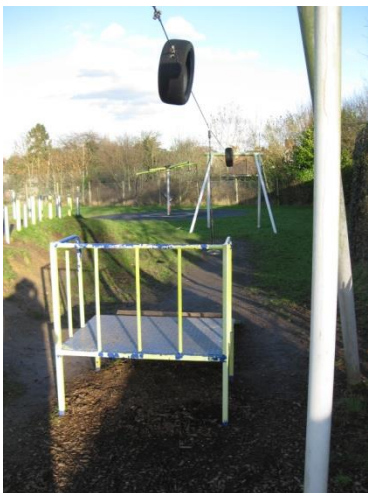
Fig.9(a). Zip wire.

The ramp and yellow railings need repainting (Fig.9a,b,c)

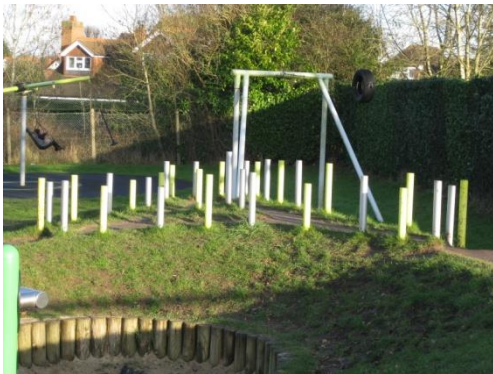
Fig.10(a). Metal posts.

Yellow and silver metal posts need repainting (Fig.10a,b)

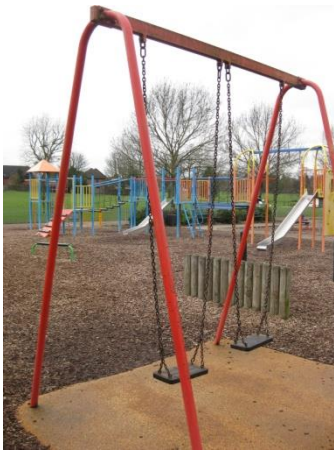
Fig.11(a). Red swing.

The red paint needs renewing (Fig.11a,b)

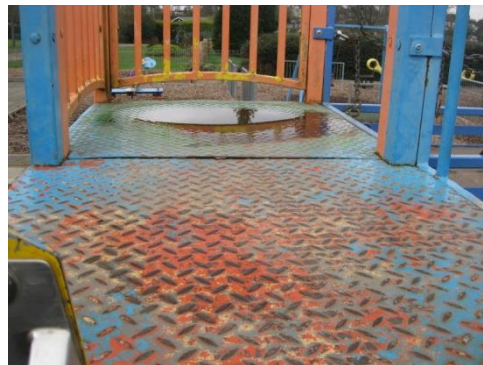
Fig.12(b). Paintwork.

Needs repainting (Fig.12b)

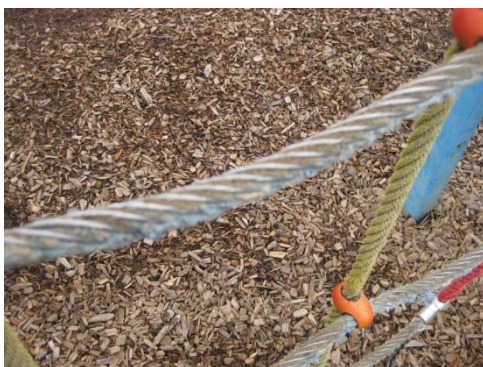
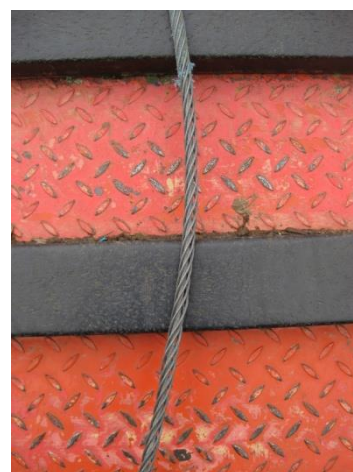
Bare metal cords are exposed where the plastic covering has worn away (Fig.12c,d)

Fig.12(c,d). Exposed metal cords.

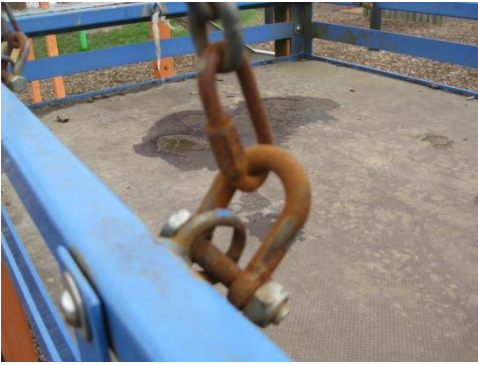
Some chain links are rusting (Fig.12e)

Fig.12(e). Rusty chain.

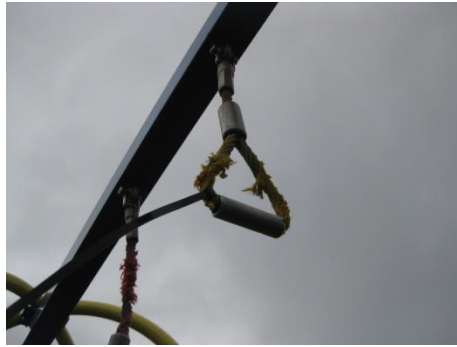
Fig.12(f). Hanging straps.

Hanging straps are frayed (Fig.12f)

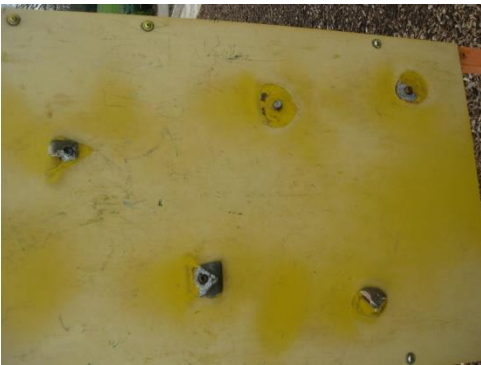
Fig.12(g). End panel with bolts.

Exposed bolts in end panel – protective covers broken or missing (Fig.12g)
