## **PUNT HILL**

**PUNT HILL PLAY EQUIPMENT**

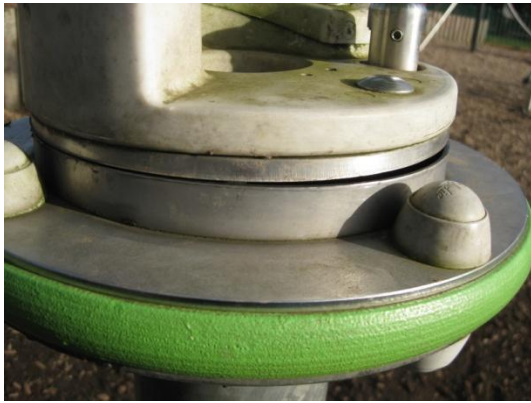
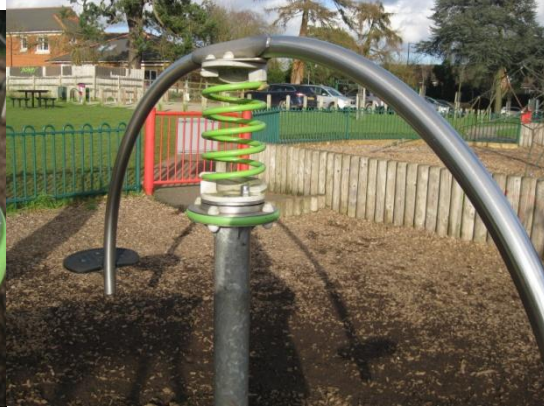
The base of the spring seesaw is loose (Fig.1 a,b)

Fig.1(a). Spring seesaw.

Fig.1(b). Base of spring seesaw.

Recommend a rigorous safety examination of all equipment to ensure that it is safe and fit for purpose.

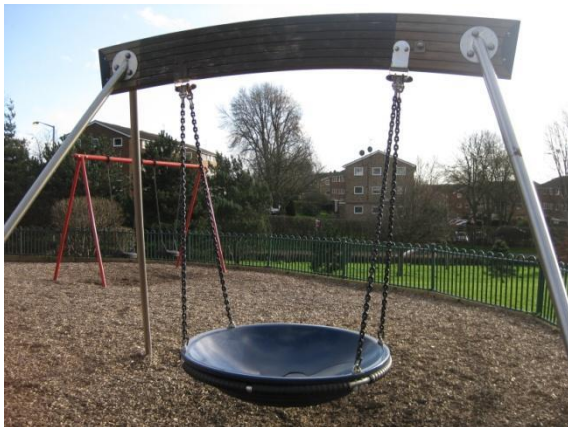
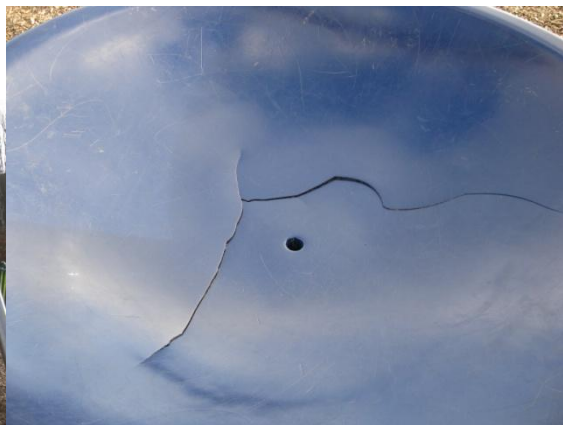
The blue saucer-shaped seat on the swing is cracked (Fig.2a,b)

Fig.2(a). Swing.

Fig.2(b). Swing seat.

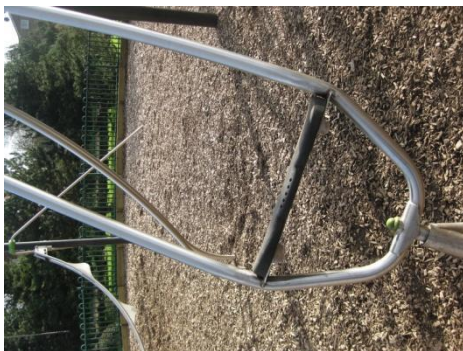
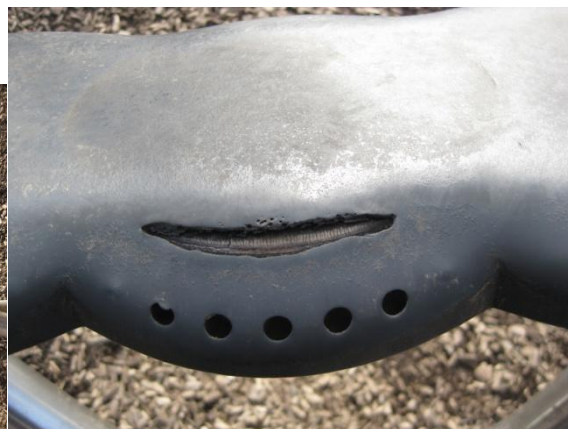
The rubber step on the activity frame is ripped (Fig.3a,b)

Fig.3(a). Rubber step on activity frame.

Fig.3(b). Activity frame.

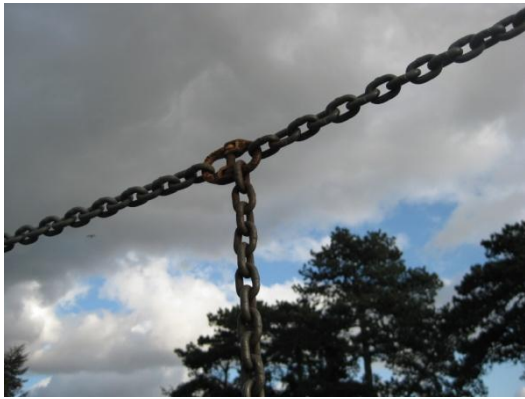
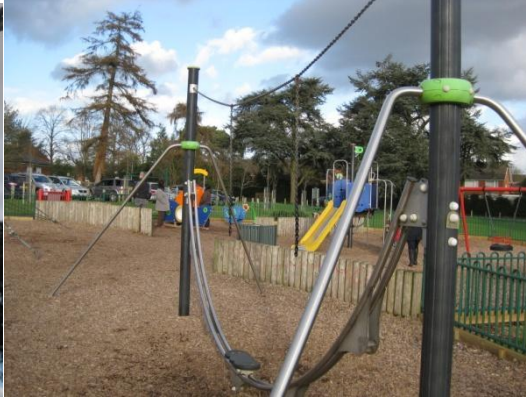
2 metal chain links on the semicircular slide are rusty (Fig.4a,b)

Fig.4(a). Semicircular slide.

Fig.4(b). Rusty chain link.

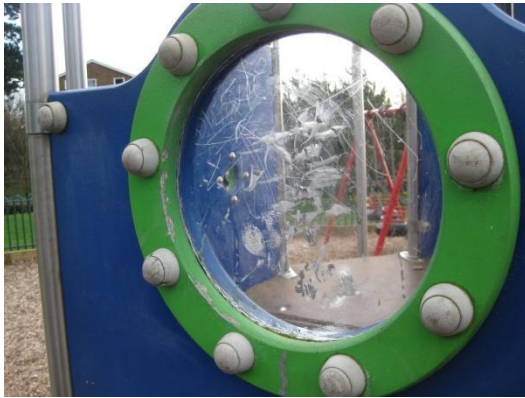
One glass/perspex “window” on the slide appears to have been burnt (Fig.5a,d)

Fig.5(a). Window on slide.

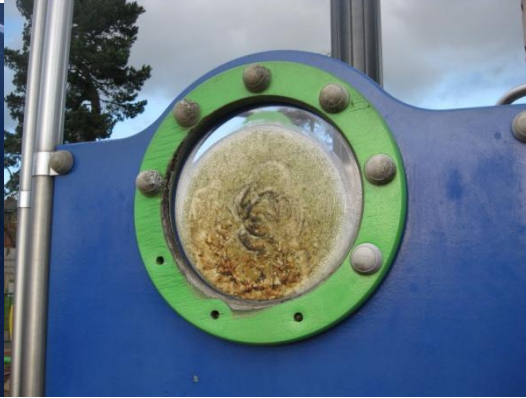
Another “window” is badly damaged (Fig.5b,d)

Fig.5(b). Window on slide.

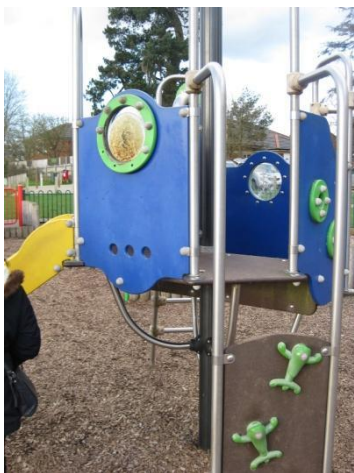
Of the 3 steps to the platform: 2 rungs are missing their wooden tops; the 3<sup>rd</sup> rung has a wooden top but is badly worn and looks as if it will soon fall off (Fig.5c,d)

Fig.5(c). Steps to platform.

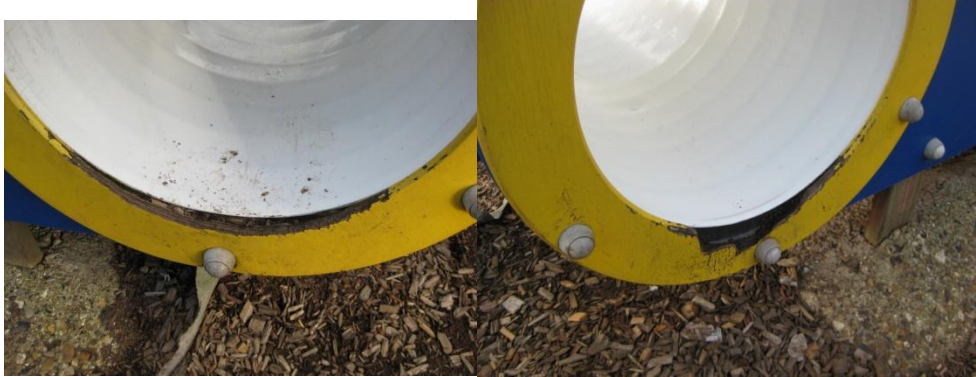
The wooden surrounds to the tunnel on the “ship” are rotting away (Fig.6a,b,d)

Fig.6(a). Tunnel surround.

Fig.6(b). Tunnel surround.

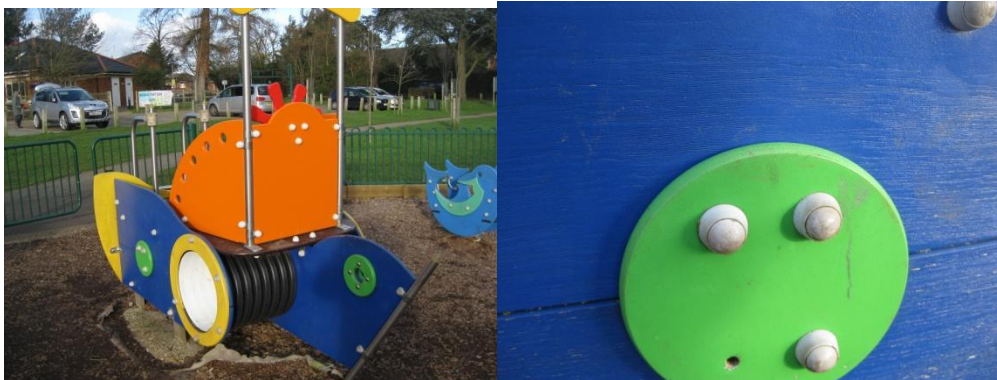
Some plastic “bolt” covers are missing (Fig.6c,d)

Fig.6(c). Bolt covers.

Fig.6(d). General view of the "ship"

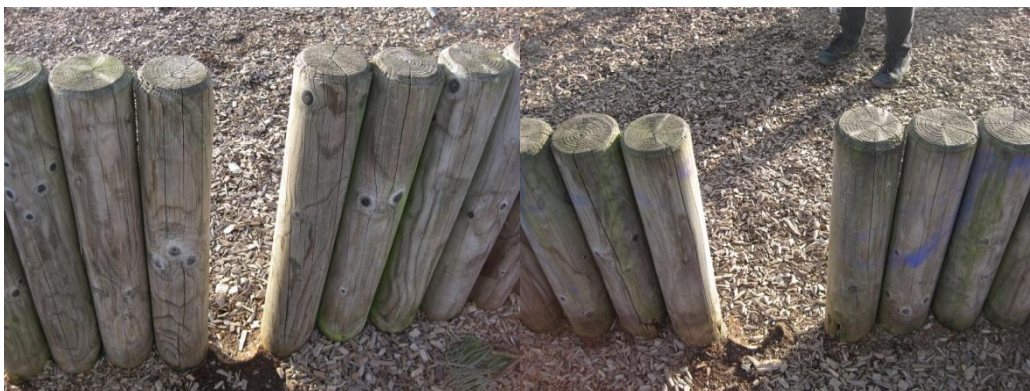
Some wooden posts are missing from the inner palisade (Fig.7).

Fig.7. Missing posts.
