## **SURVEY OF CHILDREN'S PLAY AREAS**

### **KIDWELLS PARK**

28 April 2016

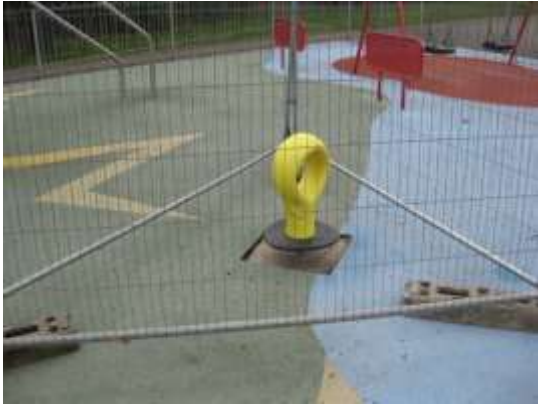
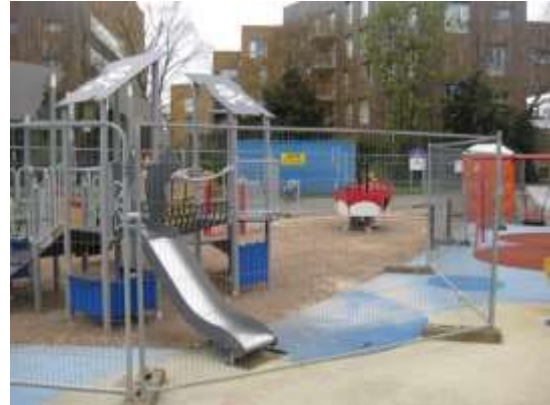
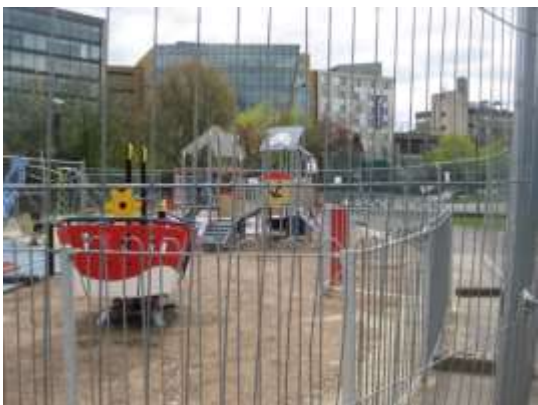
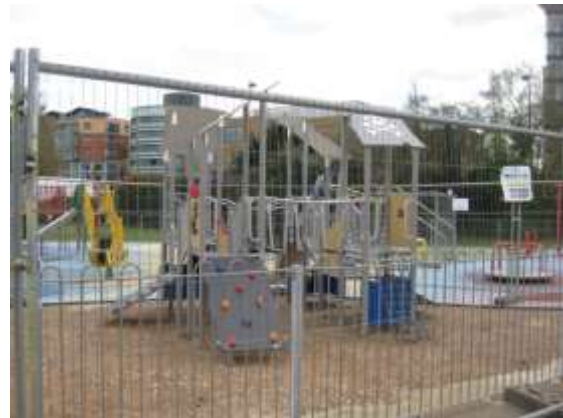
In general, this play area is in a better state of repair than Punt Hill or Oaken Grove. Barriers have been set up in two areas where it appears as if new equipment is being installed (Fig.1a,b,c,d). The composite flooring is in good condition except for one small rectangular patch (Fig.2). There is flaking paint on the signs above the entrance gates (Fig.3a,b).

Fig.1(a). Barriers round new installation.

Fig.1(b). Barriers round new installations.

Fig.1(c). Barriers round new installations.

Fig.1(d). Barriers round new installations.

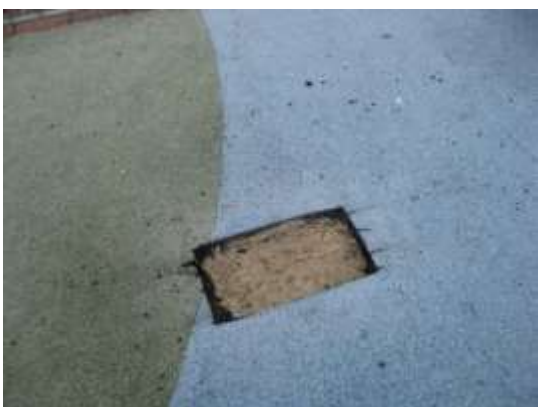
Fig.2. Small patch where flooring is missing.

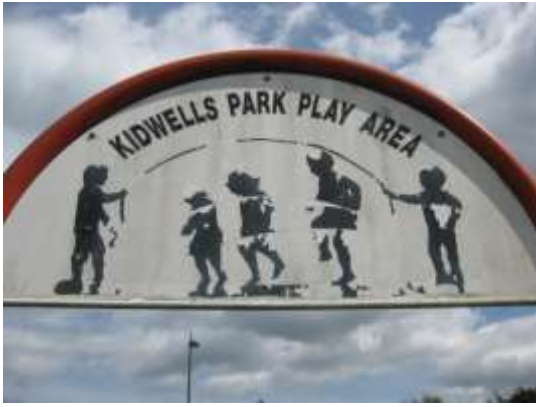
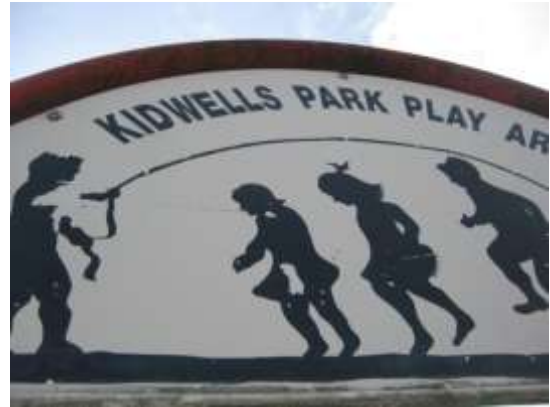
Fig.3(a). Sign above entrance.

Fig.3(b). Sign above entrance.

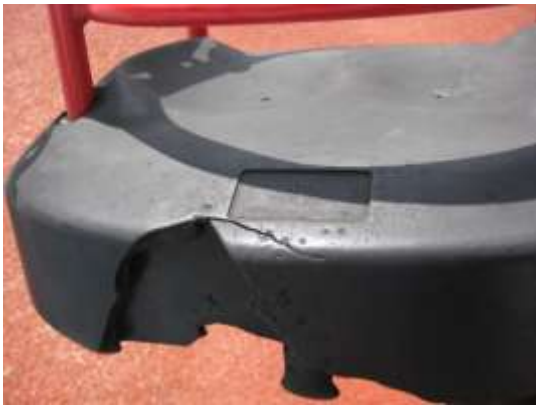
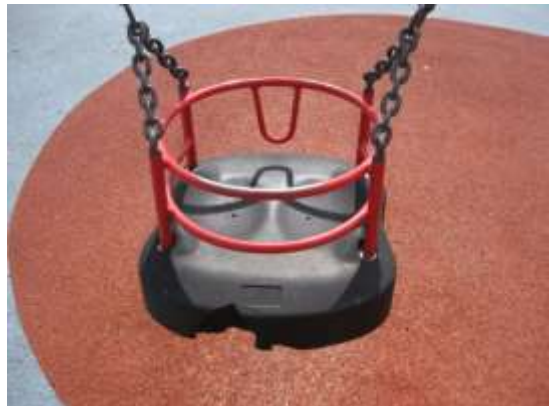
A rubber swing seat is damaged (Fig.4a,b).

Fig.4(a). Damaged swing seat.

Fig.4(b). Damaged swing seat.

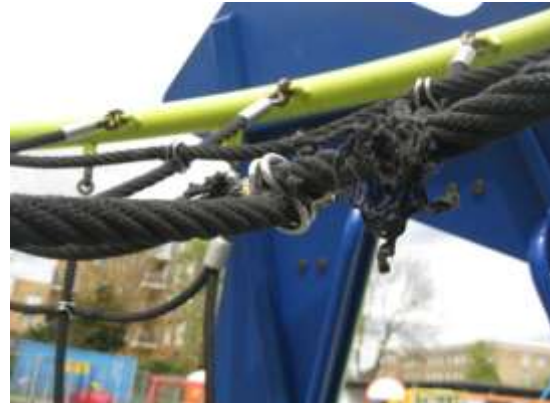
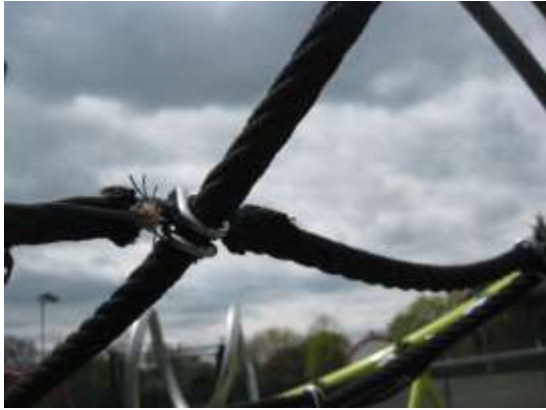
There appears to be some wear to the rope used in the climbing net (Fig.5b,c). Temporary repairs have been attempted with adhesive tape – now badly worn away (Fig.5d,e). Elsewhere, the outer protective material covering is wearing away exposing the inner metal rope (Fig.5f).

Fig.5(b). Worn climbing net.

Fig.5(c). Worn climbing net.

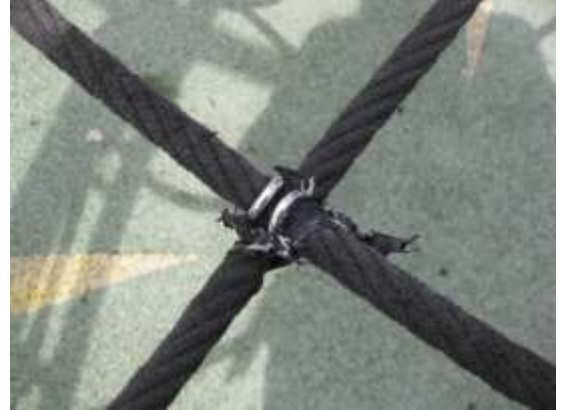
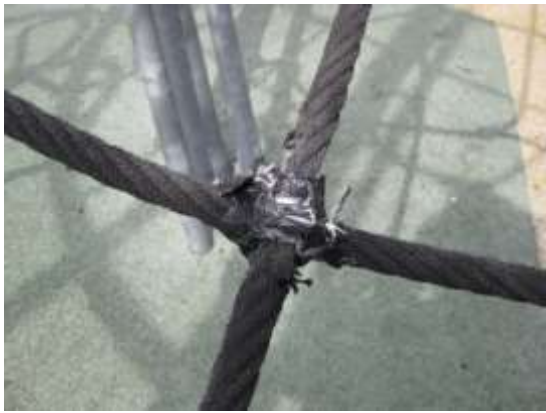
Fig.5(d). Temporary repair to climbing net.

Fig.5(e). Temporary repair to climbing net.

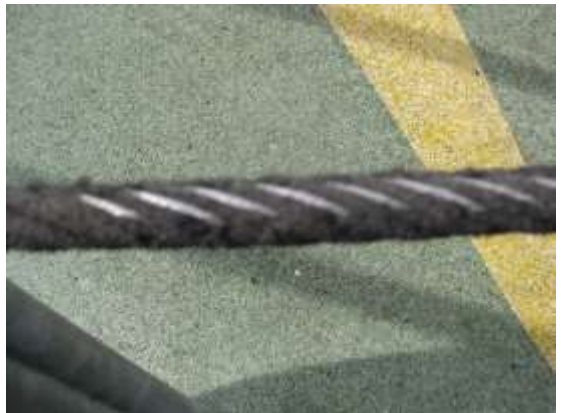
Fig.5(f). Metal rope exposed.

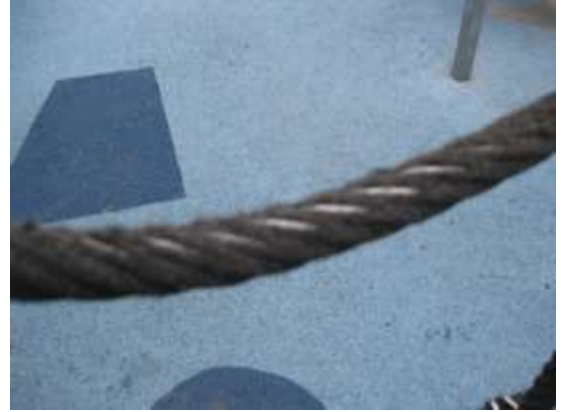
There is some wear and the metal ropes are beginning to show through (Fig.6b).

Fig.6(b). Metal rope exposed.

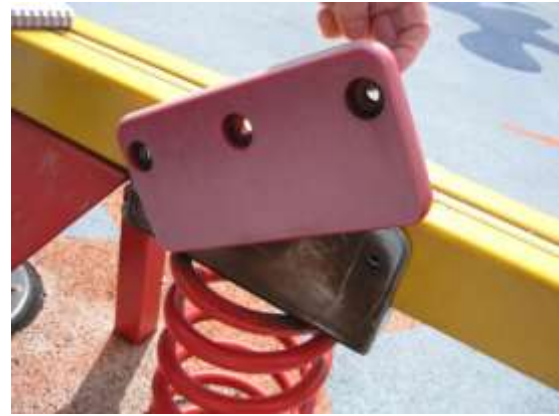
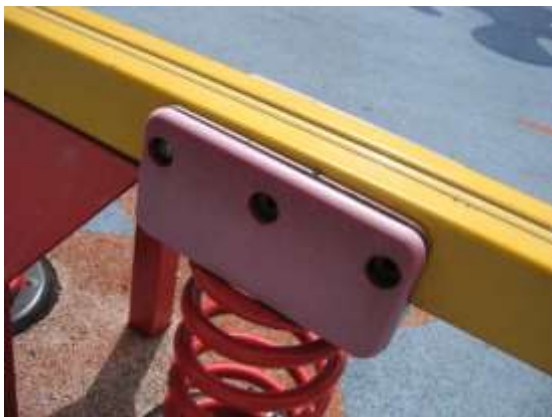
Two bolts are missing from the pink casing on the side nearest to the border fence (Fig.7b,c). One bolt is missing from the casing on the opposite side (Fig.7d).

Fig.7(b). Two missing bolts on seesaw.

Fig.7(c). Two missing bolts on seesaw.

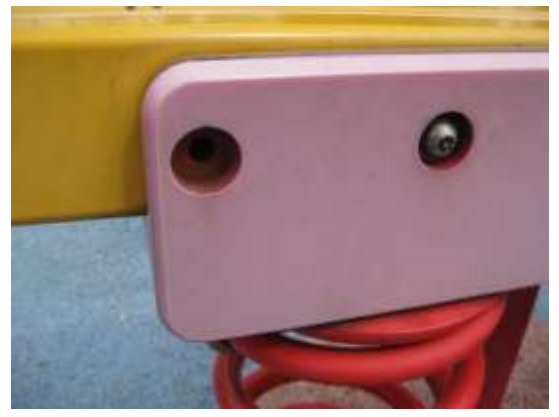
Fig.7(d). One missing bolt on seesaw.

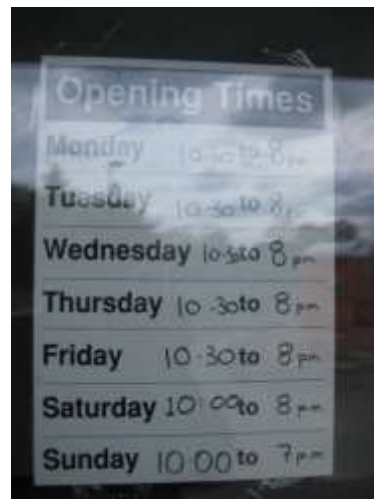
An additional comment about the café. We visited the play area on a sunny Thursday afternoon in late April at about 2.30 pm. The café was closed, despite the sign showing that it should have been open (Fig.8b). It also looked rather neglected.

Fig.8(b). Café opening times.
