## **SURVEY OF CHILDREN'S PLAY AREAS**

### **KIDWELLS PARK**

28 April 2016

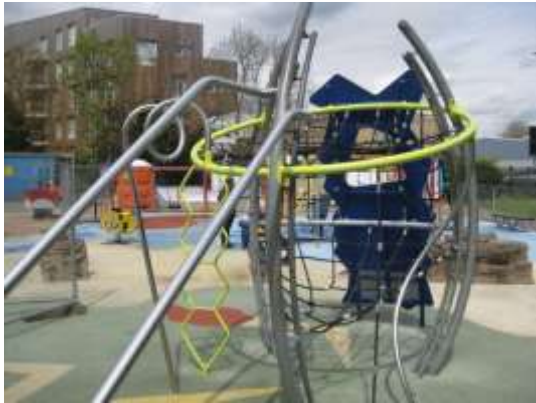
Fig.5(a). Overall view of large climbing frame.

##### **Large climbing frame (Fig.5a):**

There appears to be some wear to the rope used in the climbing net (Fig.5b,c). Temporary repairs have been attempted with adhesive tape – now badly worn away (Fig.5d,e). Elsewhere, the outer protective material covering is wearing away exposing the inner metal rope (Fig.5f).

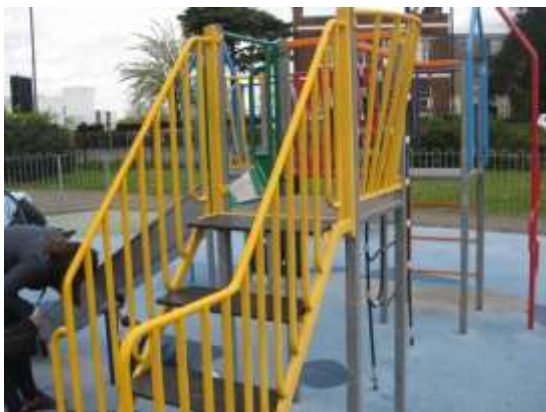
Fig.6(a). Multiactivity frame.

##### **Multiactivity frame (Fig.6a):**

There is some wear and the metal ropes are beginning to show through (Fig.6b).

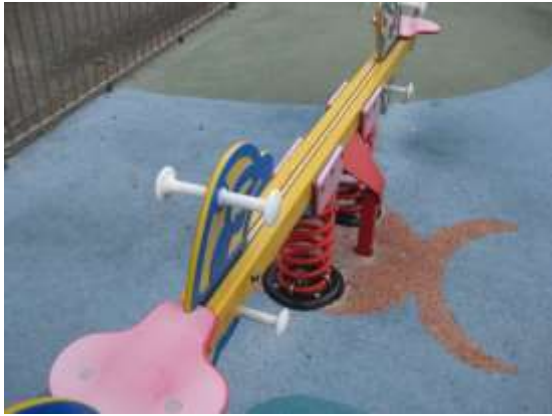
Fig.7(a). Seesaw.

##### **Seesaw (Fig.7a):**

Two bolts are missing from the pink casing on the side nearest to the border fence (Fig.7b,c). One bolt is missing from the casing on the opposite side (Fig.7d).

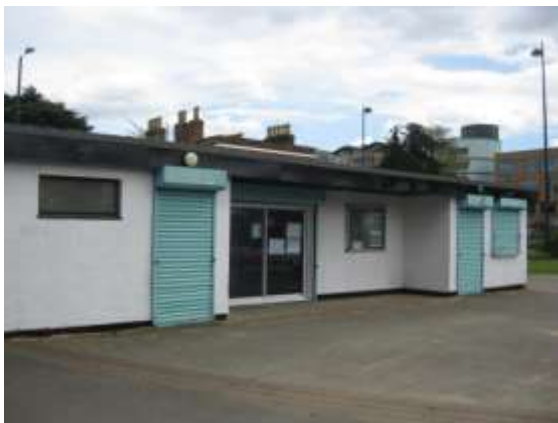
Fig.8(a). Café in Kidwells Park.

##### **Café – next to play area (Fig.8a):**

An additional comment about the café. We visited the play area on a sunny Thursday afternoon in late April at about 2.30 pm. The café was closed, despite the sign showing that it should have been open (Fig.8b). It also looked rather neglected.
